CARIBBEAN CEMENT COMPANY
KINGSTON, JAMAICA WEST INDIES

JULY 1982

UNDERWATER FACILITIES
INSPECTIONS
AND
ASSESSMENTS
AT

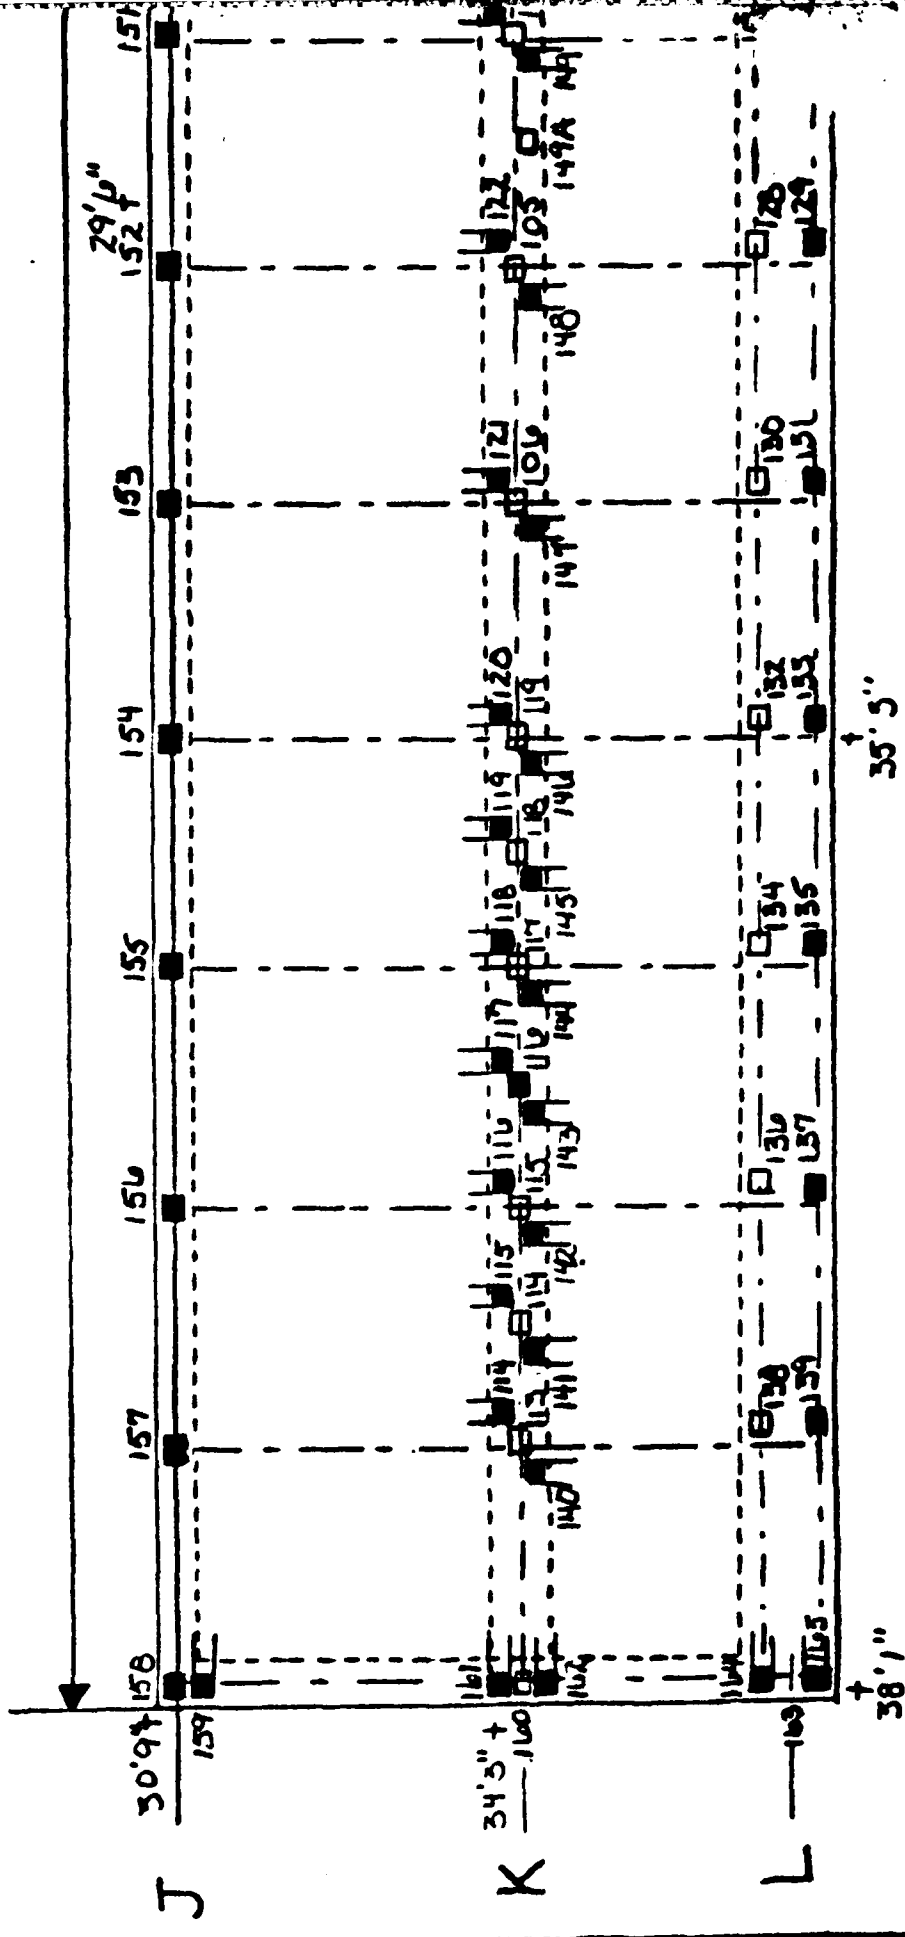
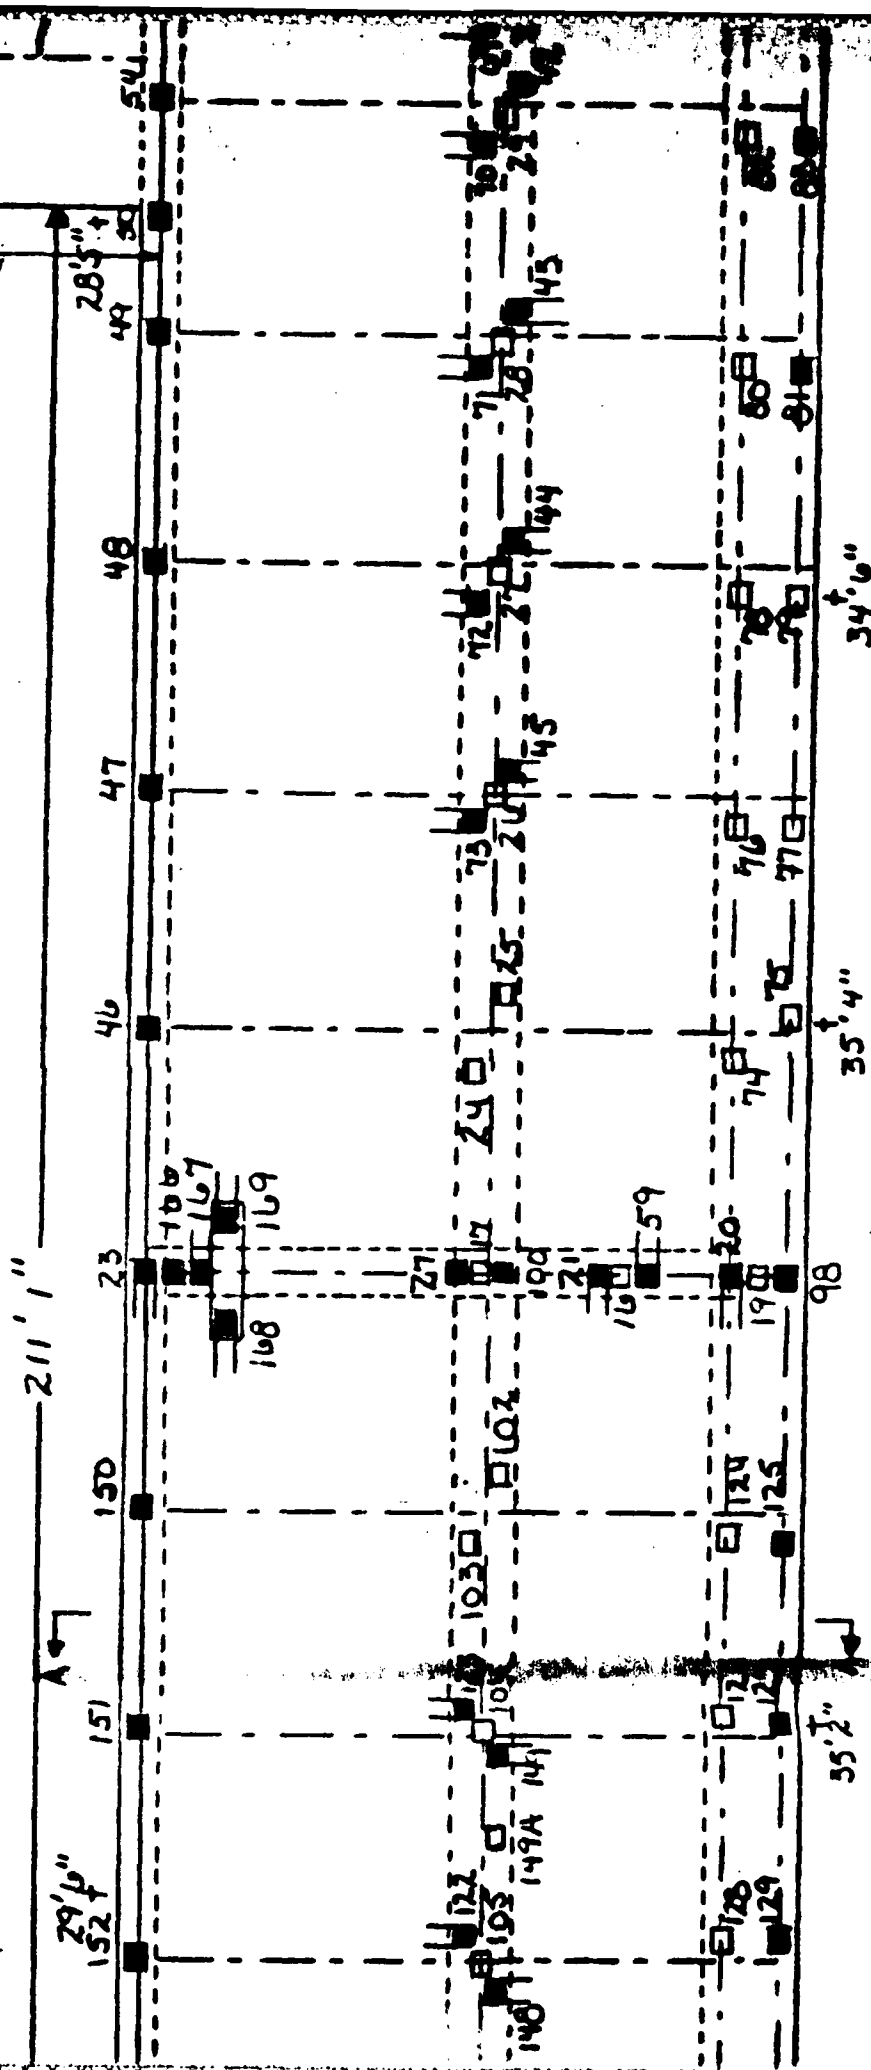
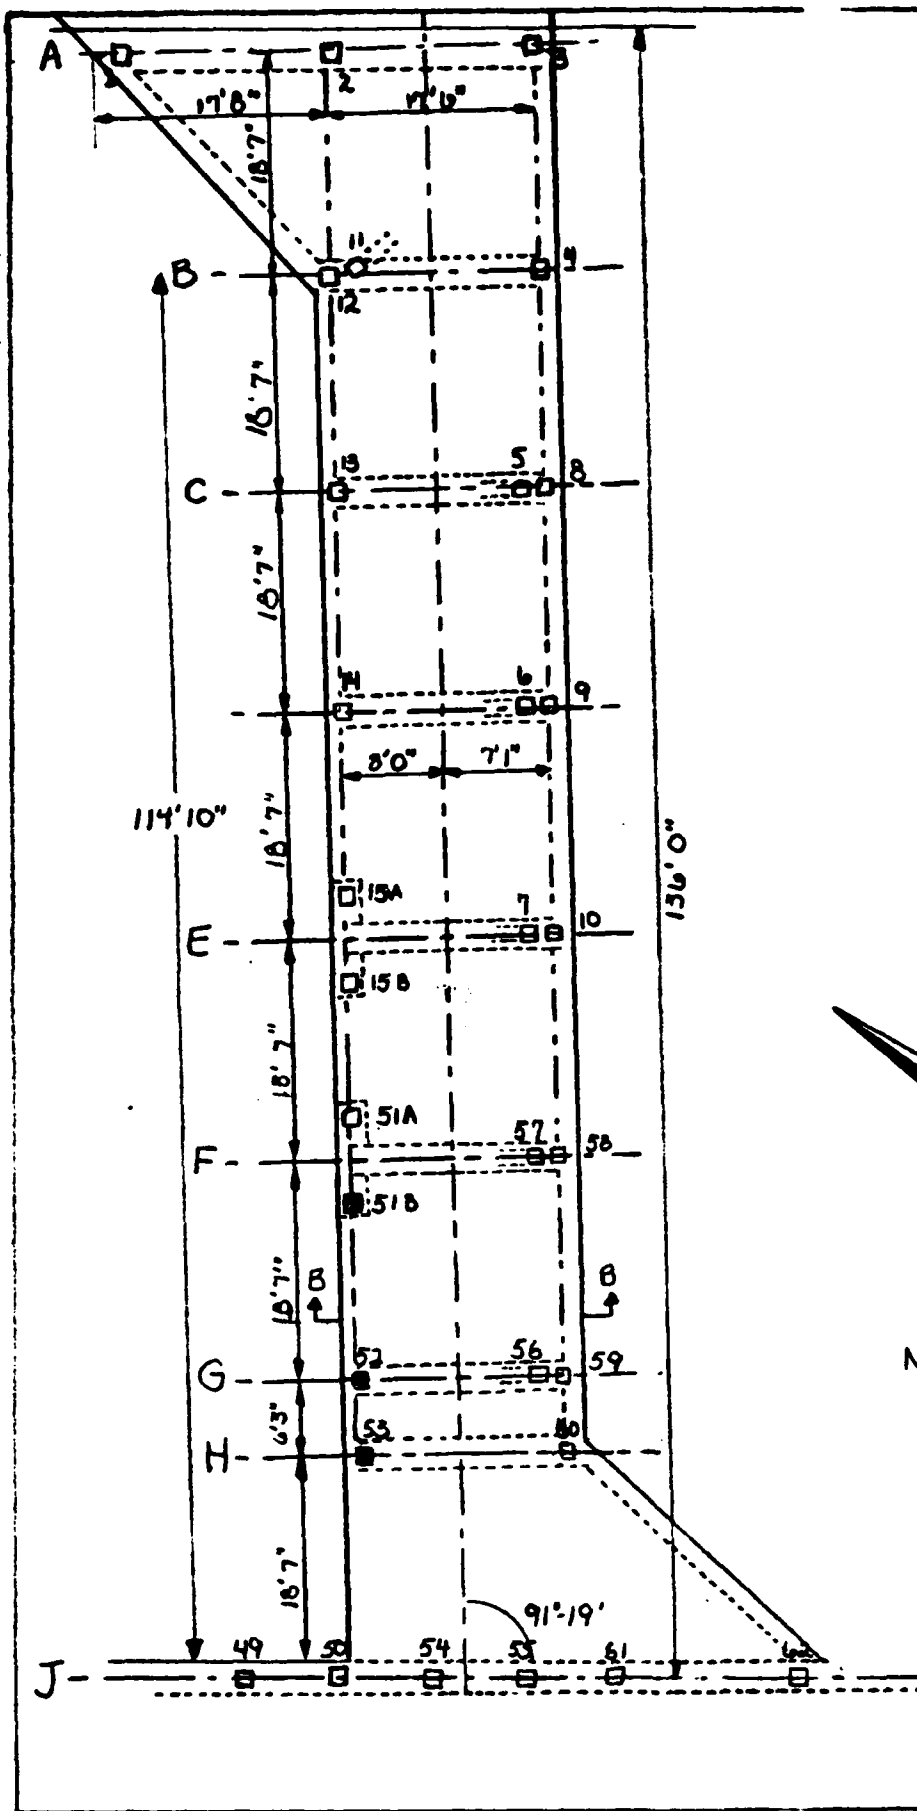
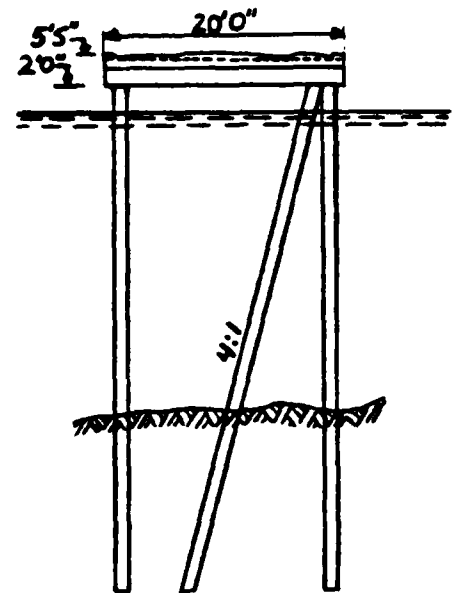
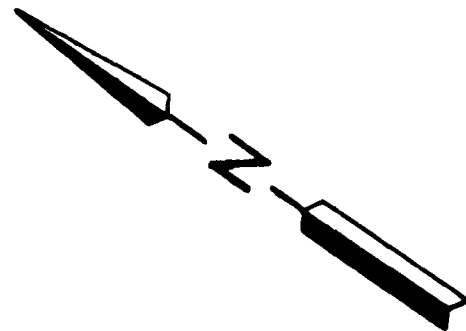
DEPARTMENT OF THE NAVY NAVAL FACILITIES ENGINEERING COMMAND
CHESAPEAKE DIVISION
WASHINGTON, D.C.
Carribbean Cement Co. Wharf
Approach Trestle
Fig 2

Starting with bent or pile cap A, as seen in photo No. 3, the underside of the deck appears in good shape as does the topside of the approach trestle. Bent A, as with the other caps within the approach showed signs of spalled concrete which in turn exposed the steel rebar. This is also true with the stringer or beam which runs from pile 1 to 12 that is shown in the same photo. Sunlight can be seen between the concrete and rebar along the bottom edge. Piles in bent A appeared good above and below water with a hard concrete material.

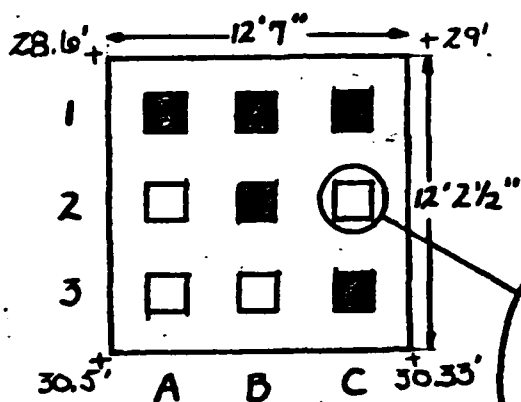
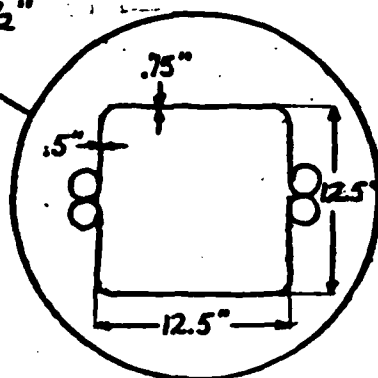
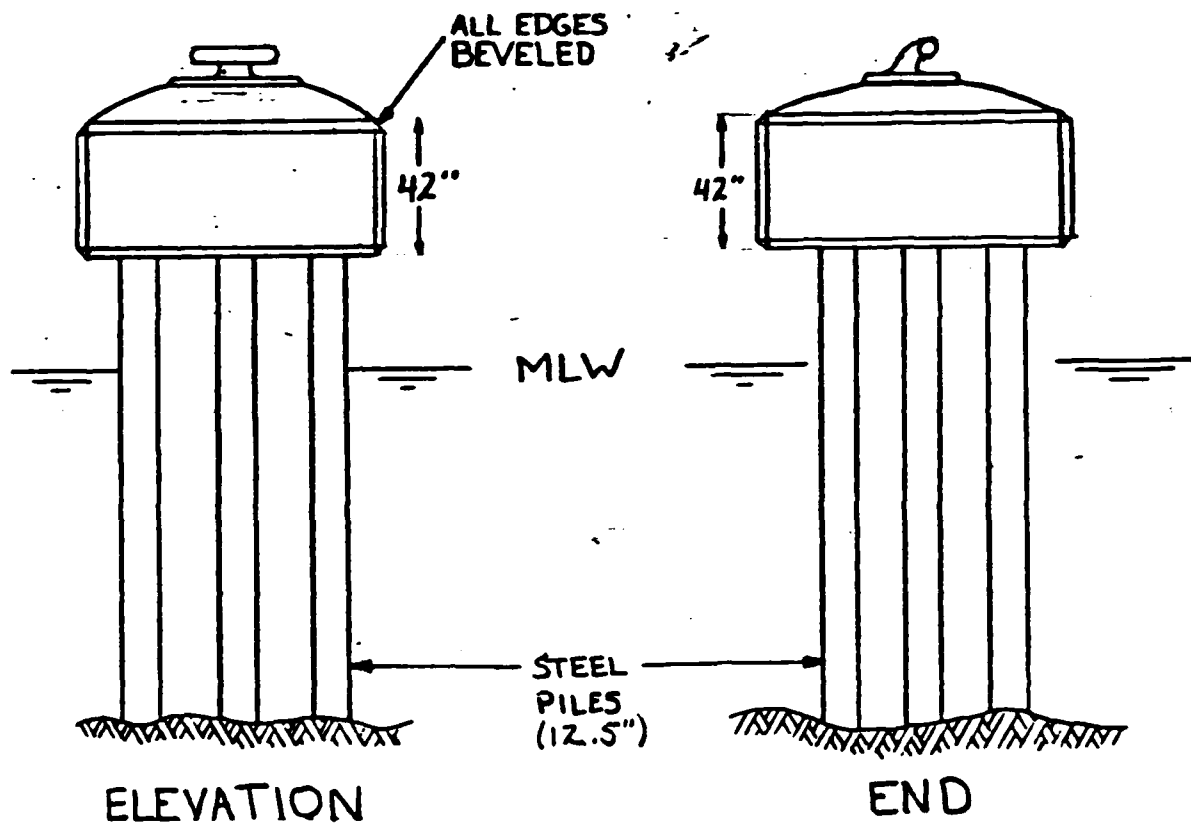
DEPARTMENT OF THE NAVY NAVAL FACILITIES ENGINEERING COMMAND
CHESAPEAKE DIVISION
WASHINGTON, D.C.
Caribbean Cement Company
Mooring Platform
(east) Fig 3

The square steel piles are of a composite design having been pieced together then welded (see figures 3 or 4). Having been driven the piles were probably filled with concrete as indicated by their solid sound after striking with a hammer.

A level I, II, and III inspection was performed on piles indicated in figures 3 and 4. Locations roughly 2 feet below MLW (mean low water) and just above the ML (mudline) were cleaned of biofouling or marine growth (see photo Nos. 29 and 30). Pits less than 1/8 inch in depth were found along with
